DEPARTMENT OF TRANSPORTATION**DIVISION OF ENGINEERING SERVICES**

Contract #: 04-0120F4Cty: SF/ALA Rte: 80 PM: 13.2/13.9File #: 1.28**WELDING INSPECTION REPORT****Resident Engineer:**Pursell, Gary**Address:** 333 Burma Road**City:** Oakland, CA 94607**Report No:** WIR-015459**Date Inspected:** 06-Jul-2010**Project Name:** SAS Superstructure**OSM Arrival Time:** 700**Prime Contractor:** American Bridge/Fluor Enterprises, a JV**OSM Departure Time:** 1530**Contractor:** American Bridge/Fluor Enterprises, a JV**Location:** Jobsite**CWI Name:** See below**CWI Present:** Yes No**Inspected CWI report:** Yes No N/A**Rod Oven in Use:** Yes No N/A**Electrode to specification:** Yes No N/A**Weld Procedures Followed:** Yes No N/A**Qualified Welders:** Yes No N/A**Verified Joint Fit-up:** Yes No N/A**Approved Drawings:** Yes No N/A**Approved WPS:** Yes No N/A**Delayed / Cancelled:** Yes No N/A**Bridge No:** 34-0006**Component:** SAS OBG**Summary of Items Observed:**

WELDING INSPECTION REPORT

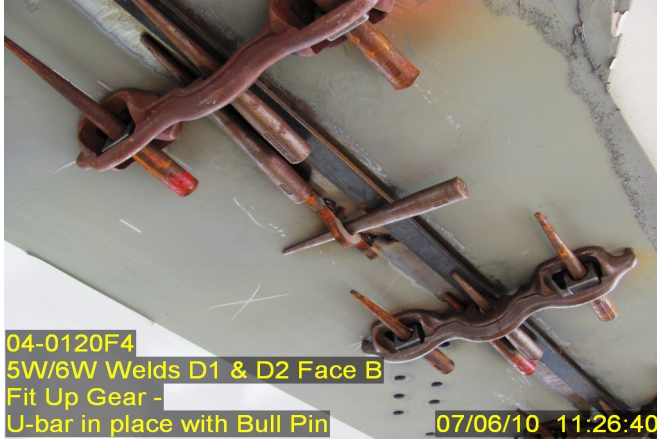
The QAI periodically observed AB/F personnel installing fit-up gear on the OBG Field Splice 5W/6W Weld ID: D1 & D2, Face B. The fit-up at this location was originally performed on Friday 7-2-10. QC Inspector Bonafacio Daquinag stated to the QAI that the backing bar had shifted and was no longer centered on the joint. On this date the fit-up gear was loosened and the fit-up was re-done by approved welder Rick Clayborn (2773). After the fit-up was completed on this date, the QC and AB/F welding personnel performed measurements from the inside of the joint and found the fit-up to be satisfactory. U-bars were welded to Face B per the SMAW process in the 4F position by approved welder Rick Clayborn. QC Inspector Bonafacio Daquinag was present to monitor the progress and verify that the welding parameters were within the limits established by the approved welding Procedure Specification (WPS) identified as ABF-WPS-D1.5-F1200-A. See photo below of an installed U-bar with bull pin.
